NASA TN D-3429

**COMPATIBILITY OF COLUMBIUM  
AND TANTALUM TUBING ALLOYS  
WITH REFLUXING POTASSIUM**

*by Coulson M. Scheuermann and Charles A. Barrett*

*Lewis Research Center*

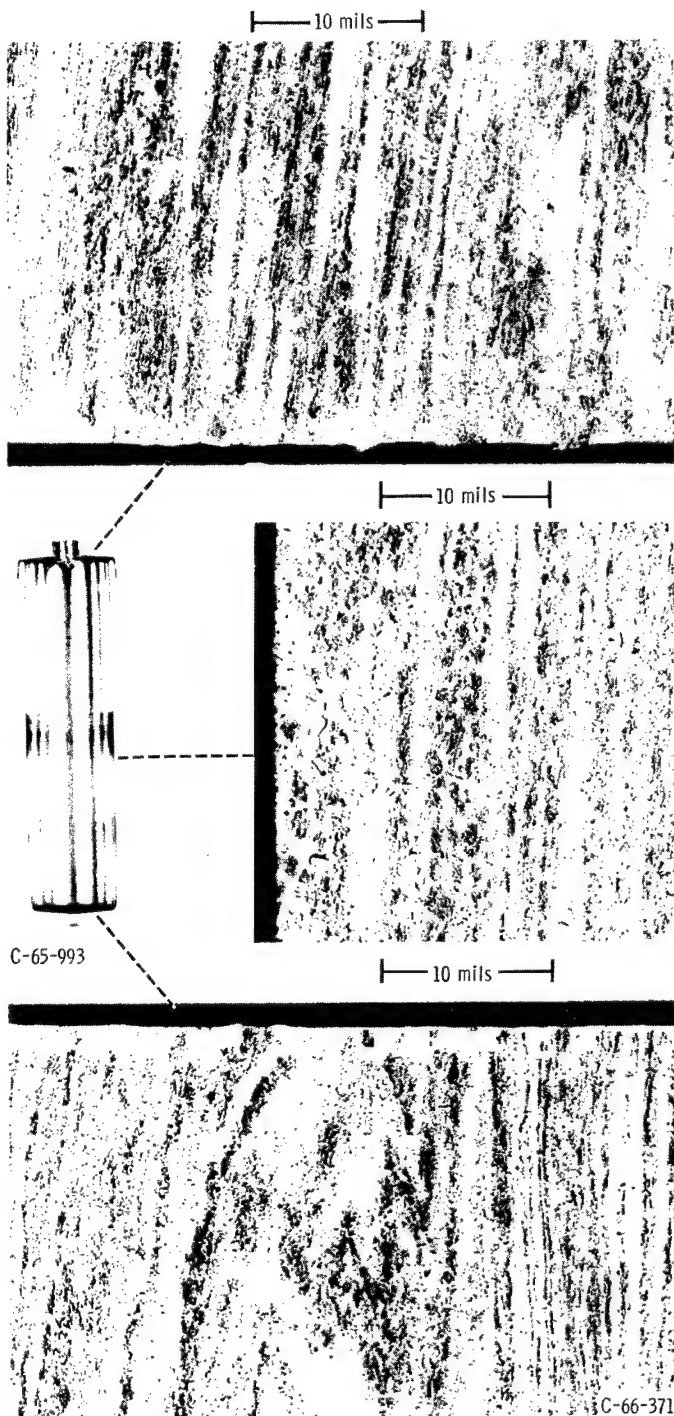
Figure 21. - Microstructures of T-222 capsule tested at 2400° F for 4000 hours with refluxing potassium.

With the exception of the capsules tested at 2400° F, very little effect of potassium was observed on T-222. At 2400° F, films were found at the liquid-vapor interfaces that reflected light, such as might be observed from crystal faces. Metallography, however, did not reveal any deposits. In areas where there were large amounts of precipitation within the alloy, there were fewer precipitates along the grain boundaries than within the grains. There appeared to be fewer precipitates along the inside edge of the capsules tested at 2400° F than in the bulk alloy, and also a slight roughening along this edge (fig. 21).

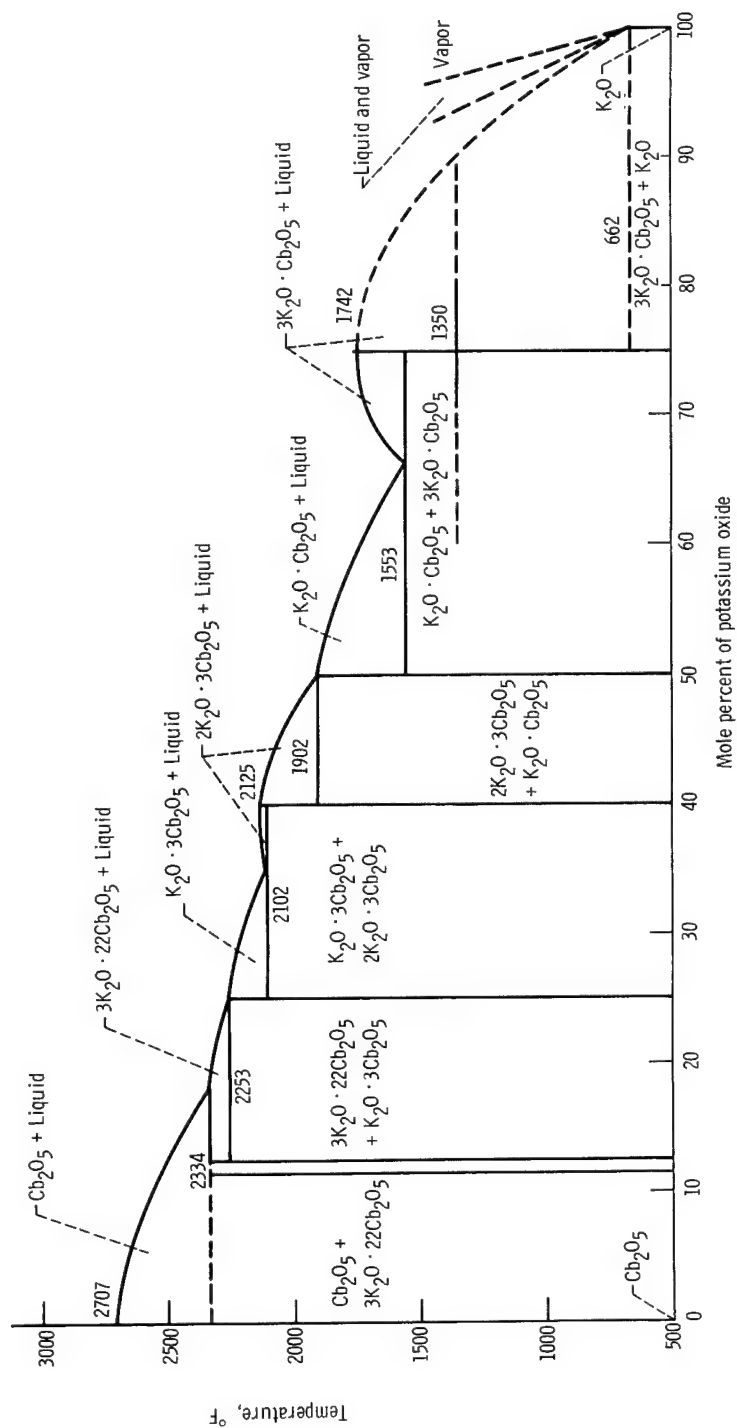
Figure 22. - Estimated  $\text{Cb}_2\text{O}_5$ - $\text{K}_2\text{O}$  phase diagram based on references 13 and 14.

columbium oxide-potassium carbonate ( $\text{Cb}_2\text{O}_5\text{-K}_2\text{CO}_3$ ) system (ref. 13). For purposes of elucidating the proposed corrosion mechanism, an estimated columbium oxide-potassium oxide ( $\text{Cb}_2\text{O}_5\text{-K}_2\text{O}$ ) phase diagram was constructed, based on references 13 and 14 (fig. 22).

Since the low oxygen ends of the refractory metal - alkali metal - oxygen ternary systems have not been investigated, it is not certain that the complex oxides shown for the binary system,  $\text{Cb}_2\text{O}_5\text{-K}_2\text{O}$  (fig. 22), are actually those phases in equilibrium with the liquid at the test temperatures. It is possible that the phases in equilibrium with the liquid are compounds formed with columbium at a lower oxidation state. This, however, should not alter the basic corrosion pattern, only the composition of the complex oxide formed. It is also likely that these unknown complex oxides would have melting points
